LAWRENCE
LIVERMORE
NATIONAL
LABORATORY

LLNL-TR-648143

A Visual Description of the Concrete Exterior of the Cactus Crater Containment Structure

October 2013

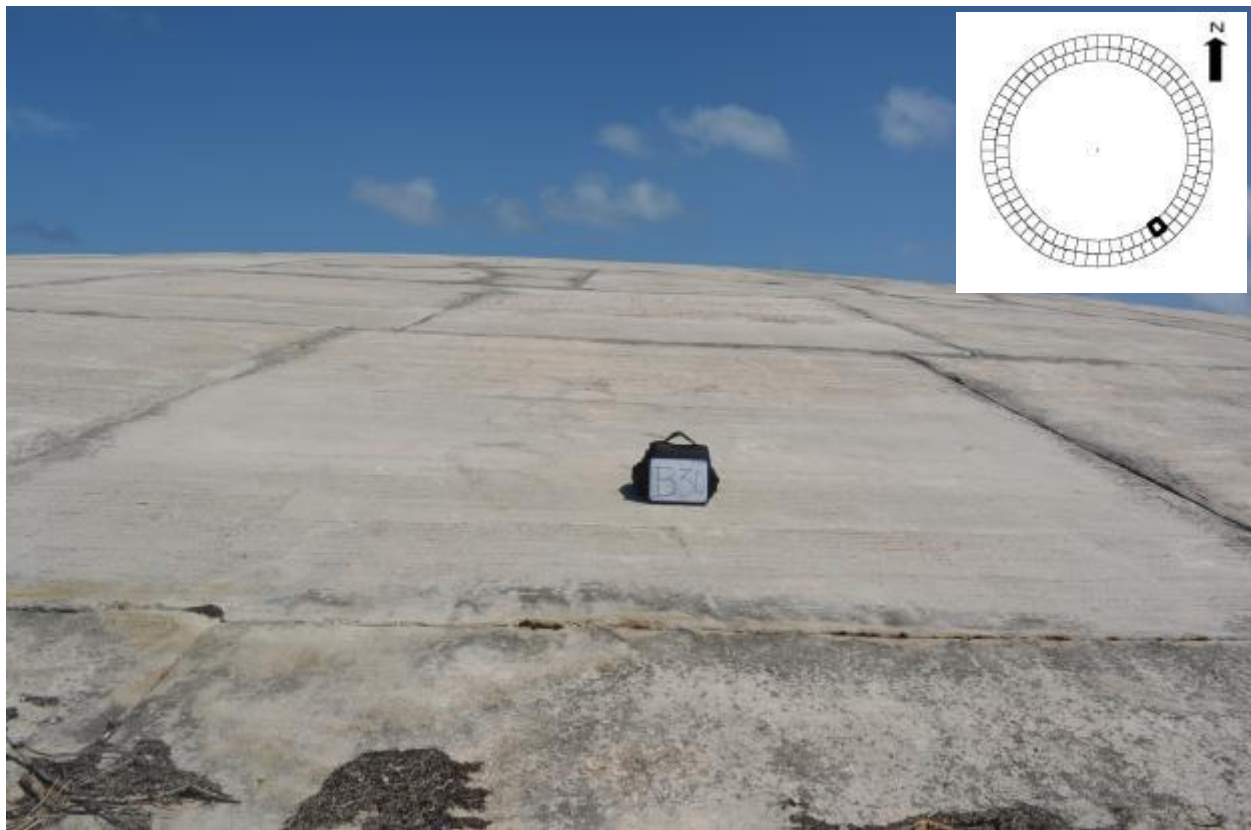
CAP SECTION LOCATION: Panel B30

No significant or obvious interior cracks extending across the top of the panel. The upper portion of the panel has a relatively rough appearance. Rooting vegetation removed from along the panel seams. Some minor spalling of concrete observed in the upper left-hand corner of the panel, and along the bottom seam overhanging the A panel below.

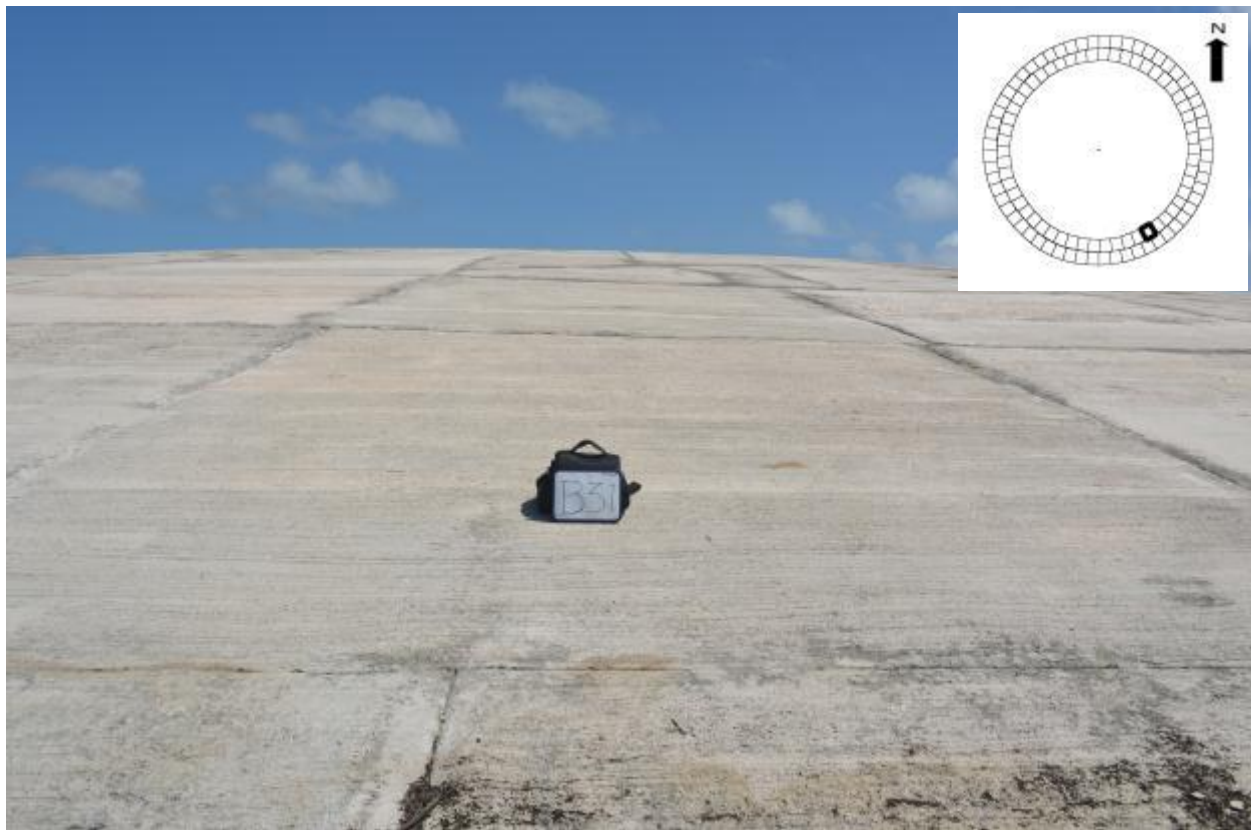
CAP SECTION LOCATION: Panel B31

No significant or obvious interior cracks extending across the top of the panel. The panel appears to have a relatively rough appearance. Rooting vegetation removed from along the panel seams. Some spalling/chipping of concrete observed in the upper right-hand corner of the panel.

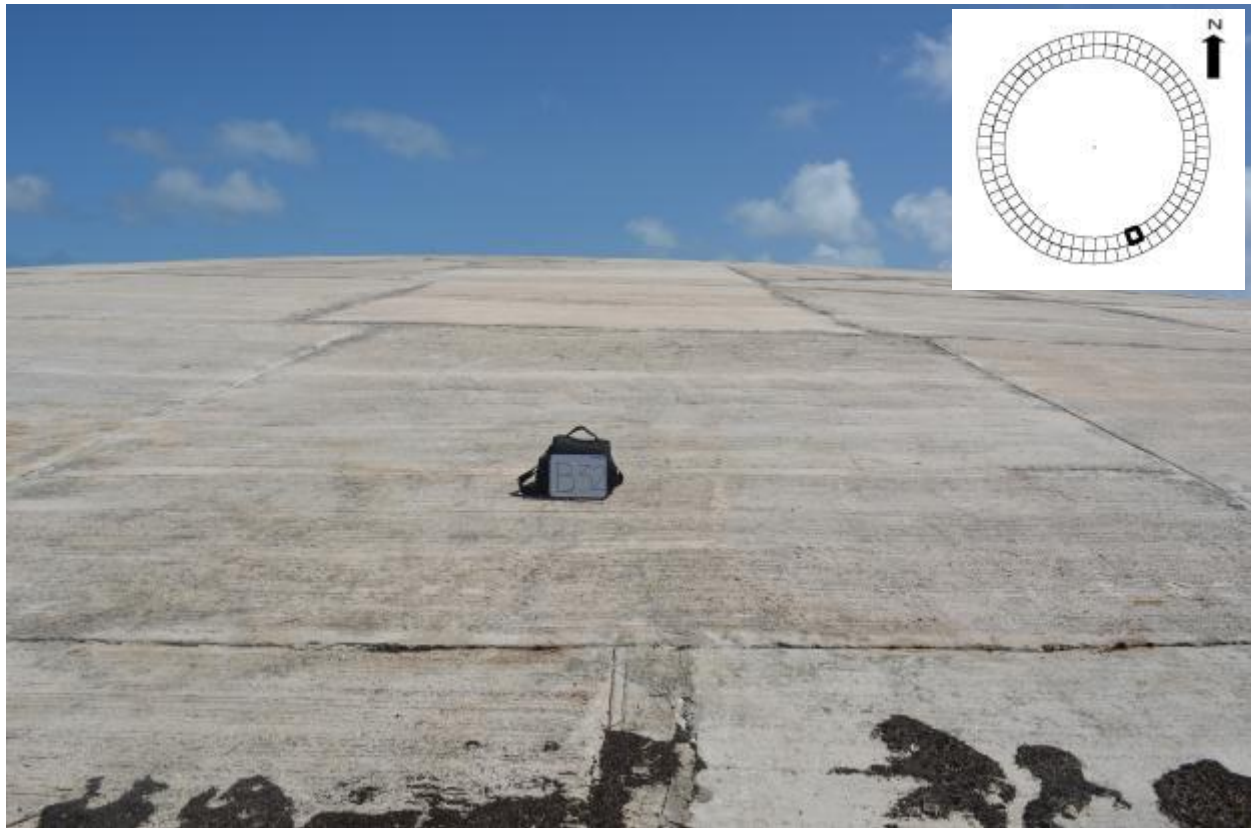
CAP SECTION LOCATION: Panel B32

No significant or obvious interior cracks extending across the top of the panel. The upper section of the panel has a relatively rough appearance. Rooting vegetation removed from along the panel seams.

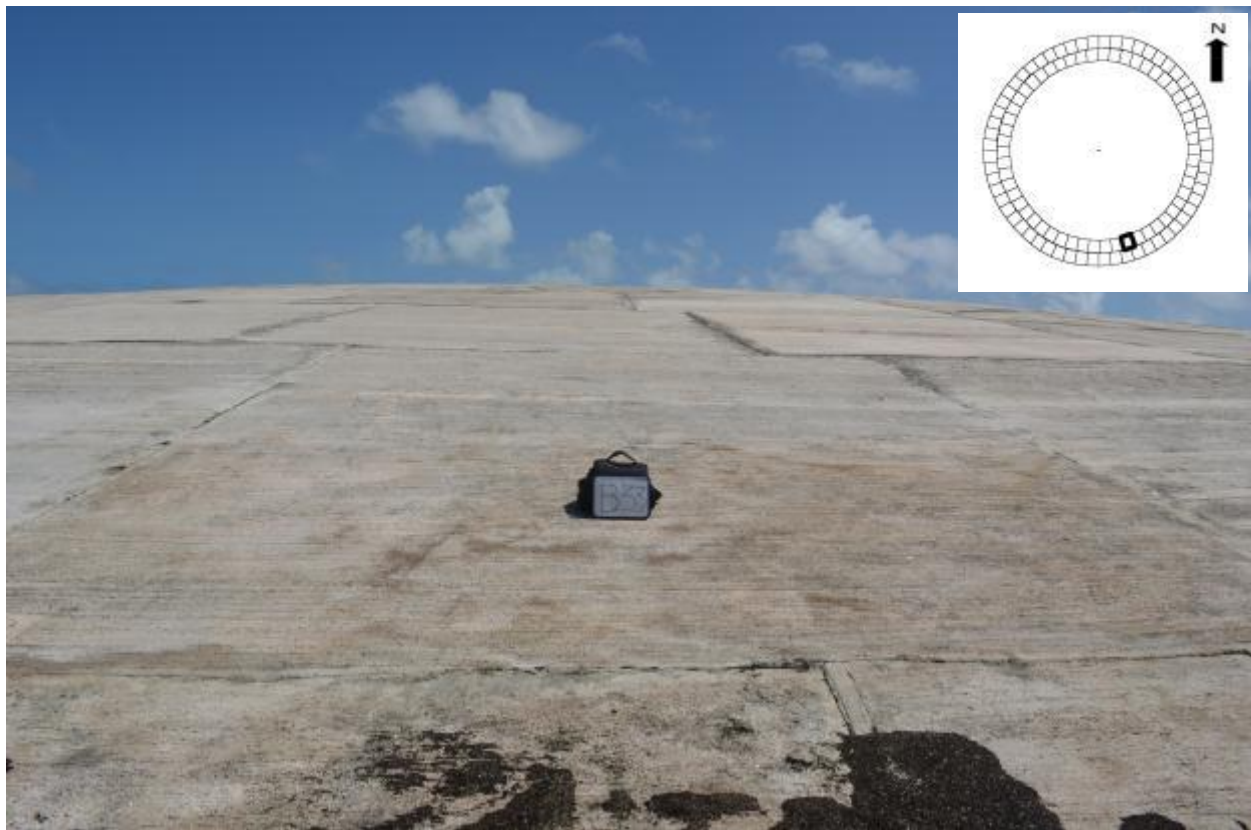
CAP SECTION LOCATION: Panel 33

No significant or obvious interior cracks extending across the top of the panel. The panel has a rough and weathered appearance. Some minor spalling of concrete observed in the upper left-hand corner of the panel, and along the bottom left seam adjacent to the intersecting corners between the A panels below.

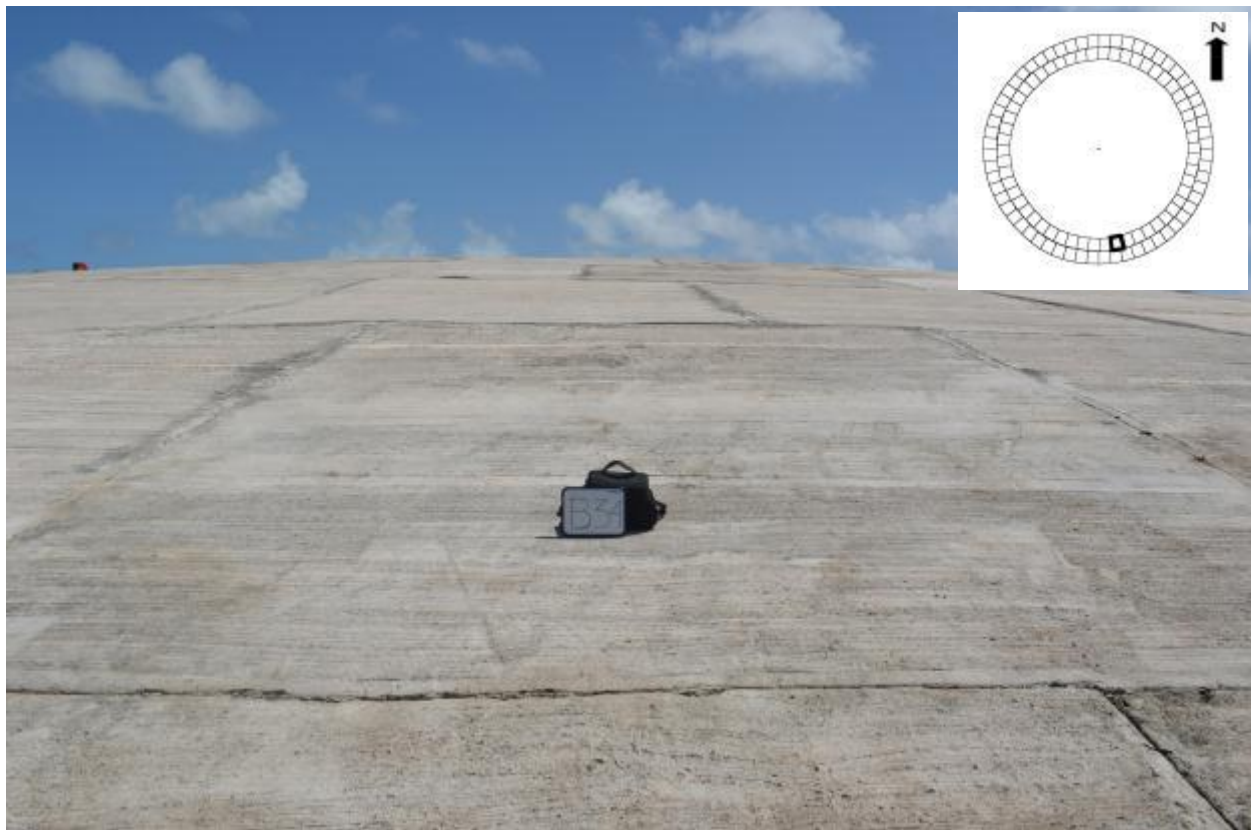
CAP SECTION LOCATION: Panel B34

No significant or obvious interior cracks extending across the top of the panel. The upper portion of the panel appears to have a relatively rough appearance. Rooting vegetation removed from along the panel seams. Some minor spalling of concrete observed along the upper seam of the panel.

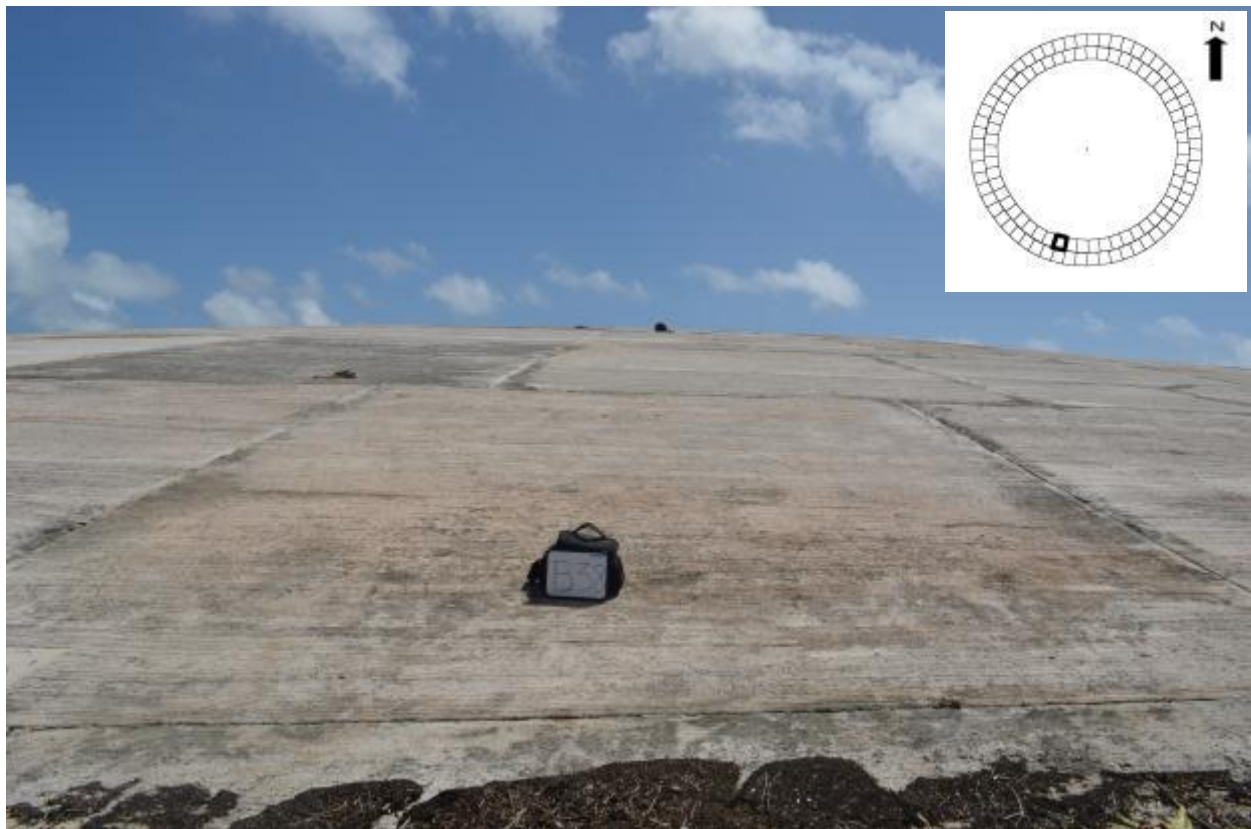
No significant or obvious interior cracks extending across the top of the panel. The panel has a rough and weathered appearance. Rooting vegetation removed from along the panel seams. Some minor spalling of concrete observed in the bottom left-hand corner of the panel. There appears to be deeper and more obvious cracks running along the seam joints compared with those appearing around the majority of panels.

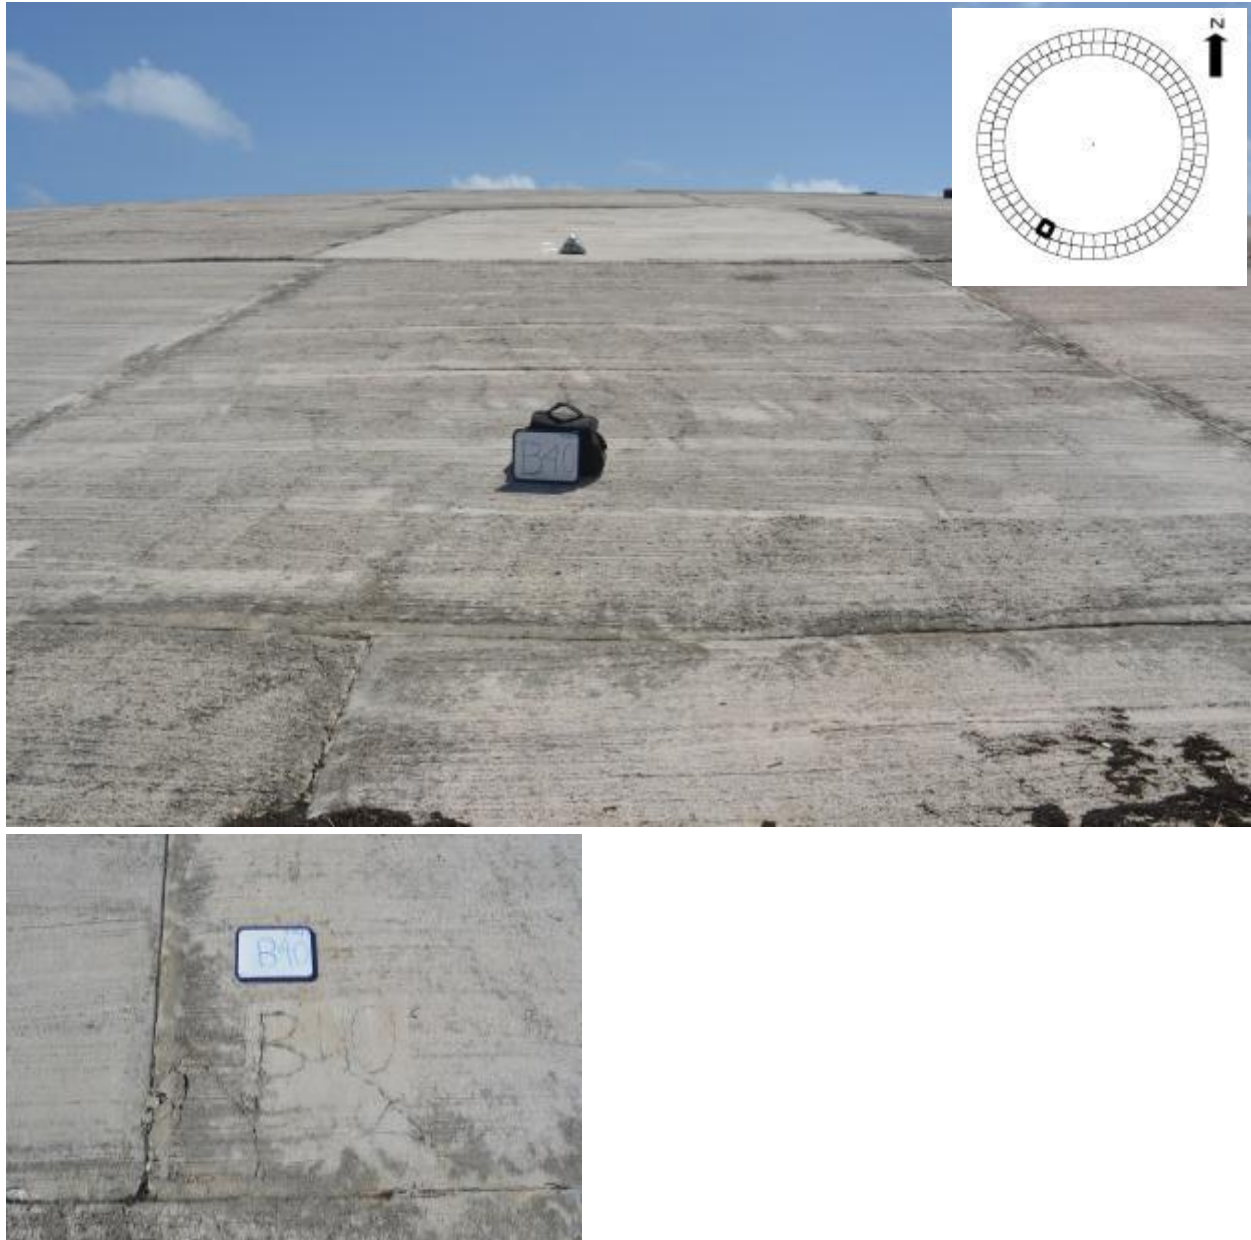
There is a significantly cracked section of concrete with spalled edges in the lower left-hand corner of the panel. Some minor spalling of concrete also observed in the upper left-hand corner of the panel.

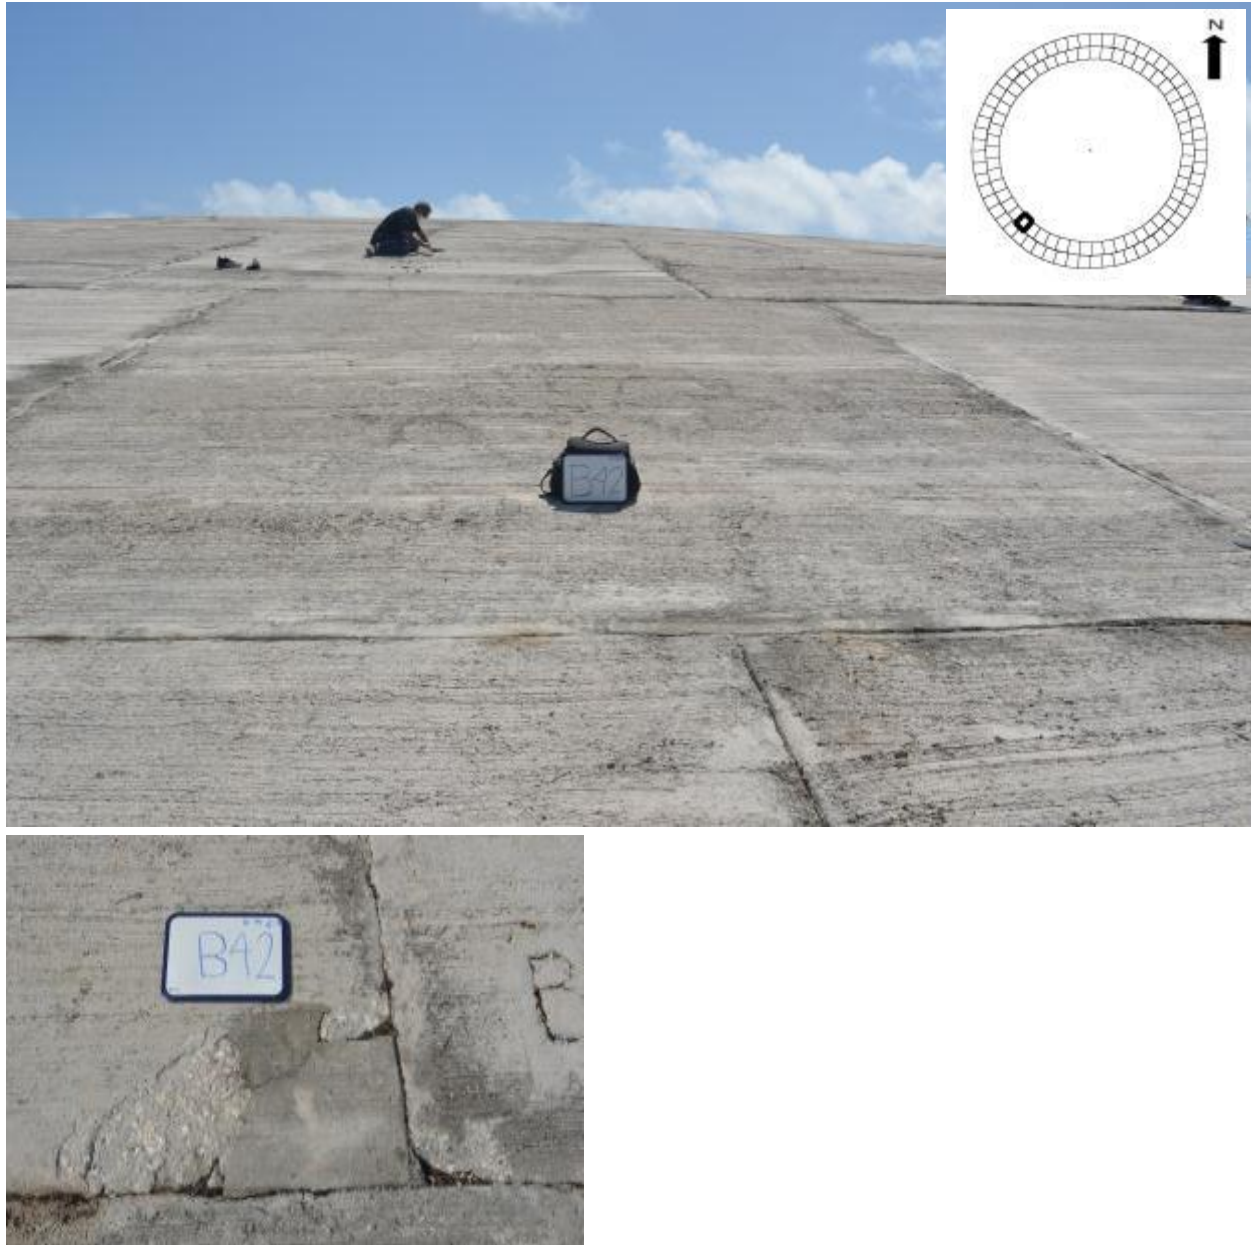
No significant or obvious interior cracks extending across the top of the panel. The panel has a rough and weathered appearance. There is a significantly cracked/spalled section of concrete in the lower right-hand corner of the panel. Rooting vegetation removed from along the panel seams. Panel B43 to B51 were skipped.

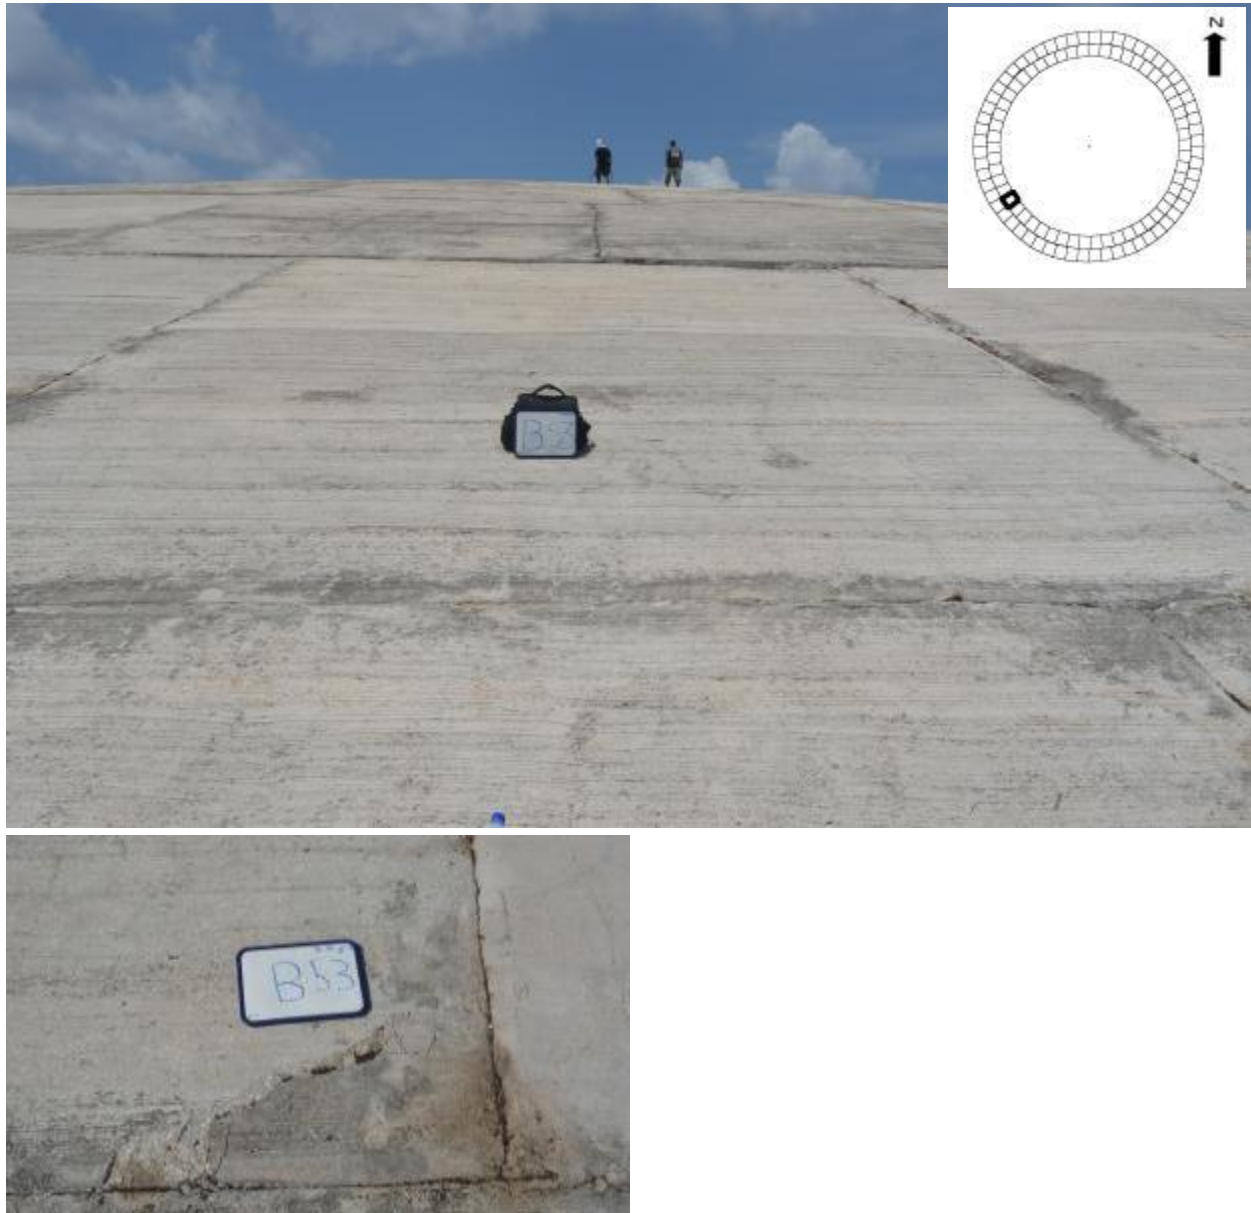
No significant or obvious interior cracks extending across the top of the panel. Rooting vegetation removed from along the panel seams. Some spalling of concrete observed in the lower right-hand corner of the panel.

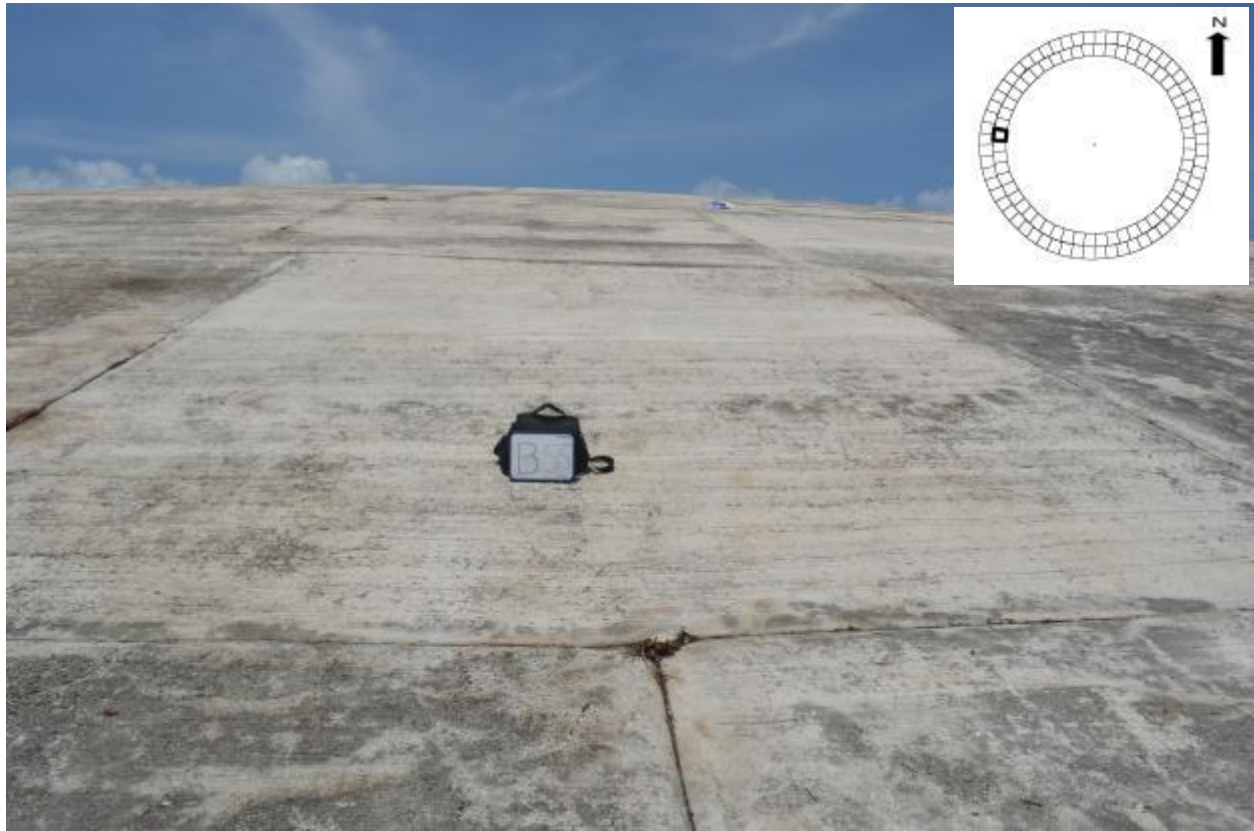
No significant or obvious interior cracks extending across the top of the panel. Rooting vegetation removed from along the panel seams.

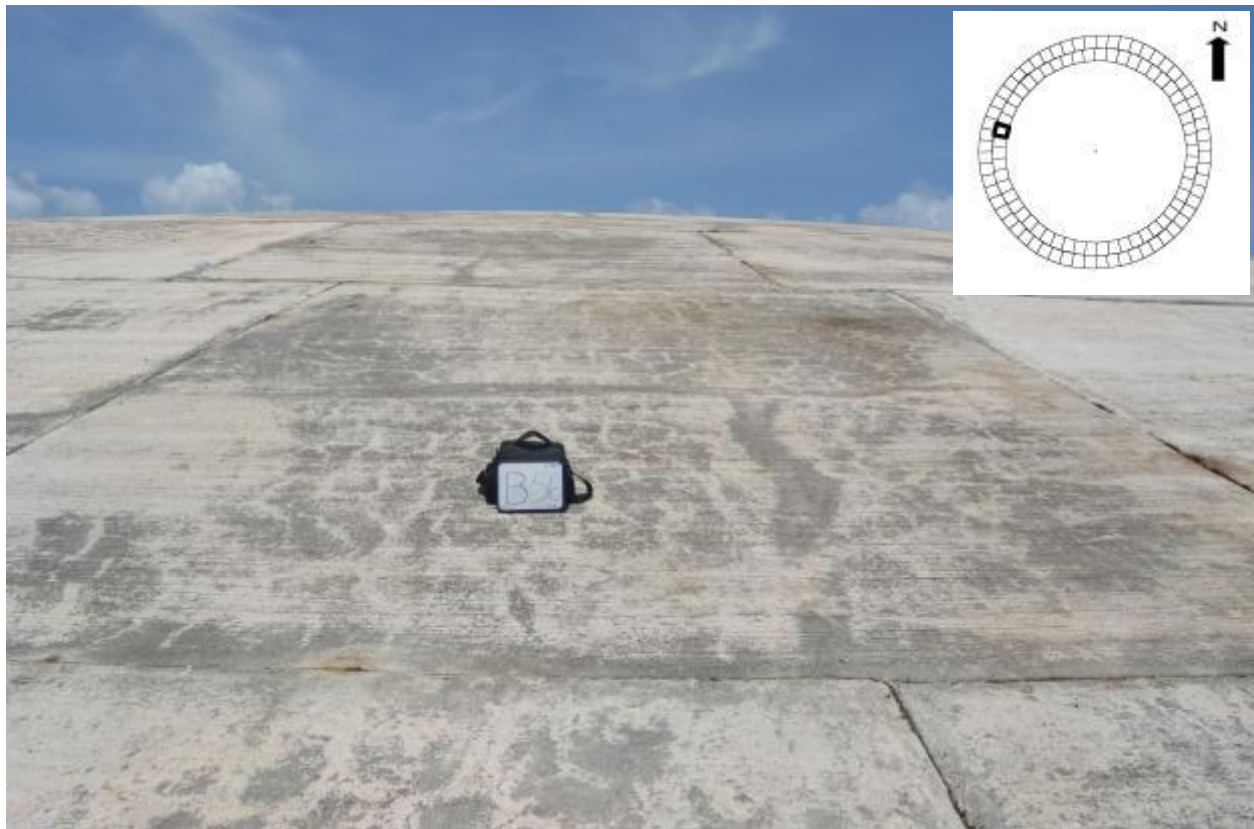
CAP SECTION LOCATION: Panel B56_duplicate

The panel has a relatively rough and weathered appearance.. Rooting vegetation removed from along the panel seams. A minor crack observed traversing across the segment at about a mid-point up the panel.

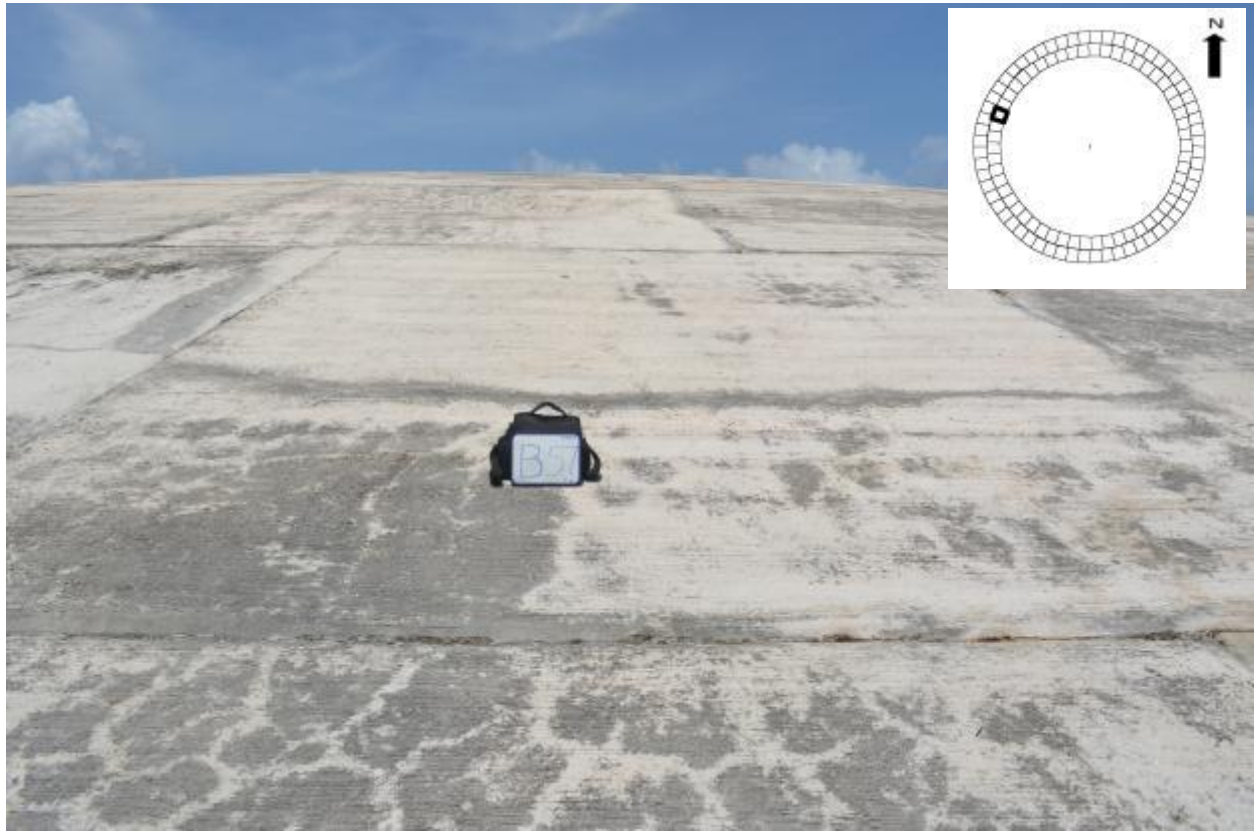
CAP SECTION LOCATION: Panel B57_duplicate

Rooting vegetation removed from along the panel seams. A crack observed traversing across the segment between 2 to 3 meters up from the bottom of the panel.

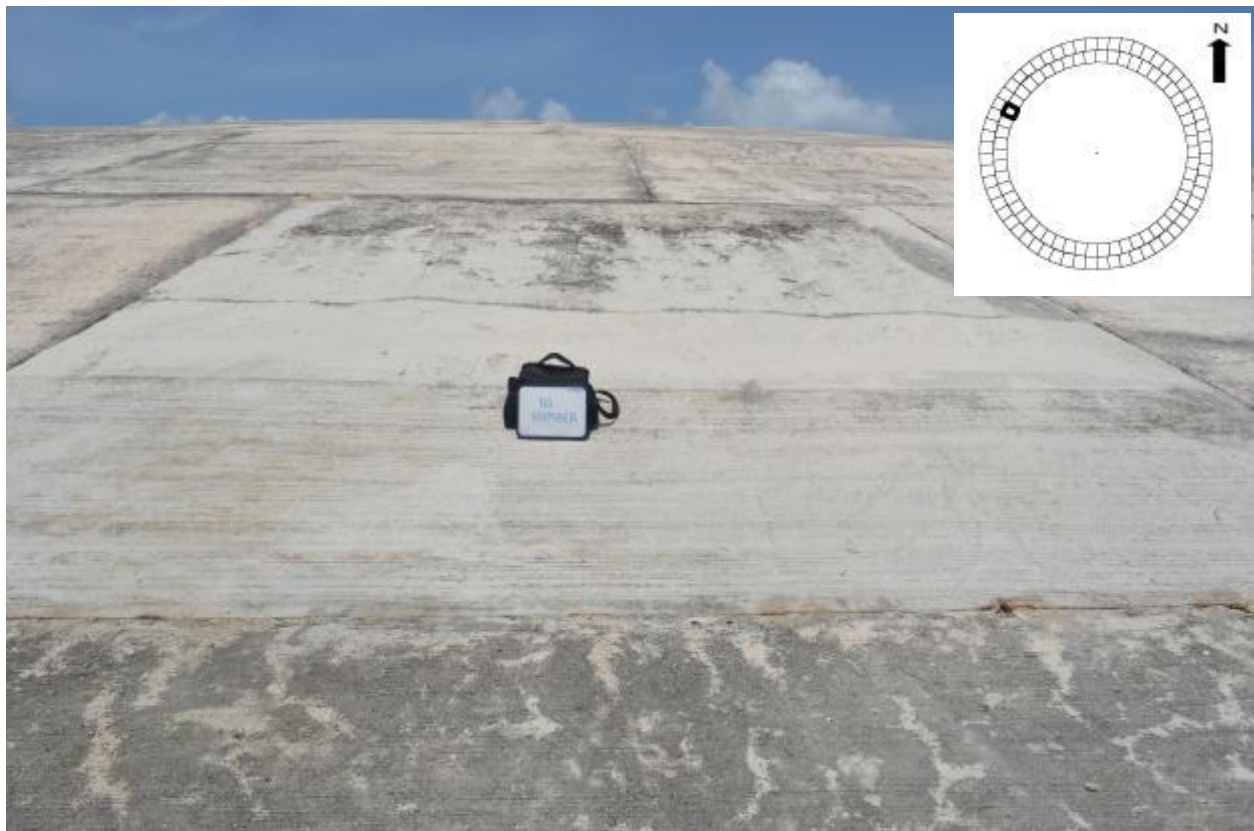
CAP SECTION LOCATION: Panel No ID

Rooting vegetation removed from along the panel seams. A crack observed traversing across the segment at about a mid-point up the panel. Some spalling of concrete observed in the bottom right-hand corner of the panel as well as along the bottom seam at the intersecting corner with the A panels below.

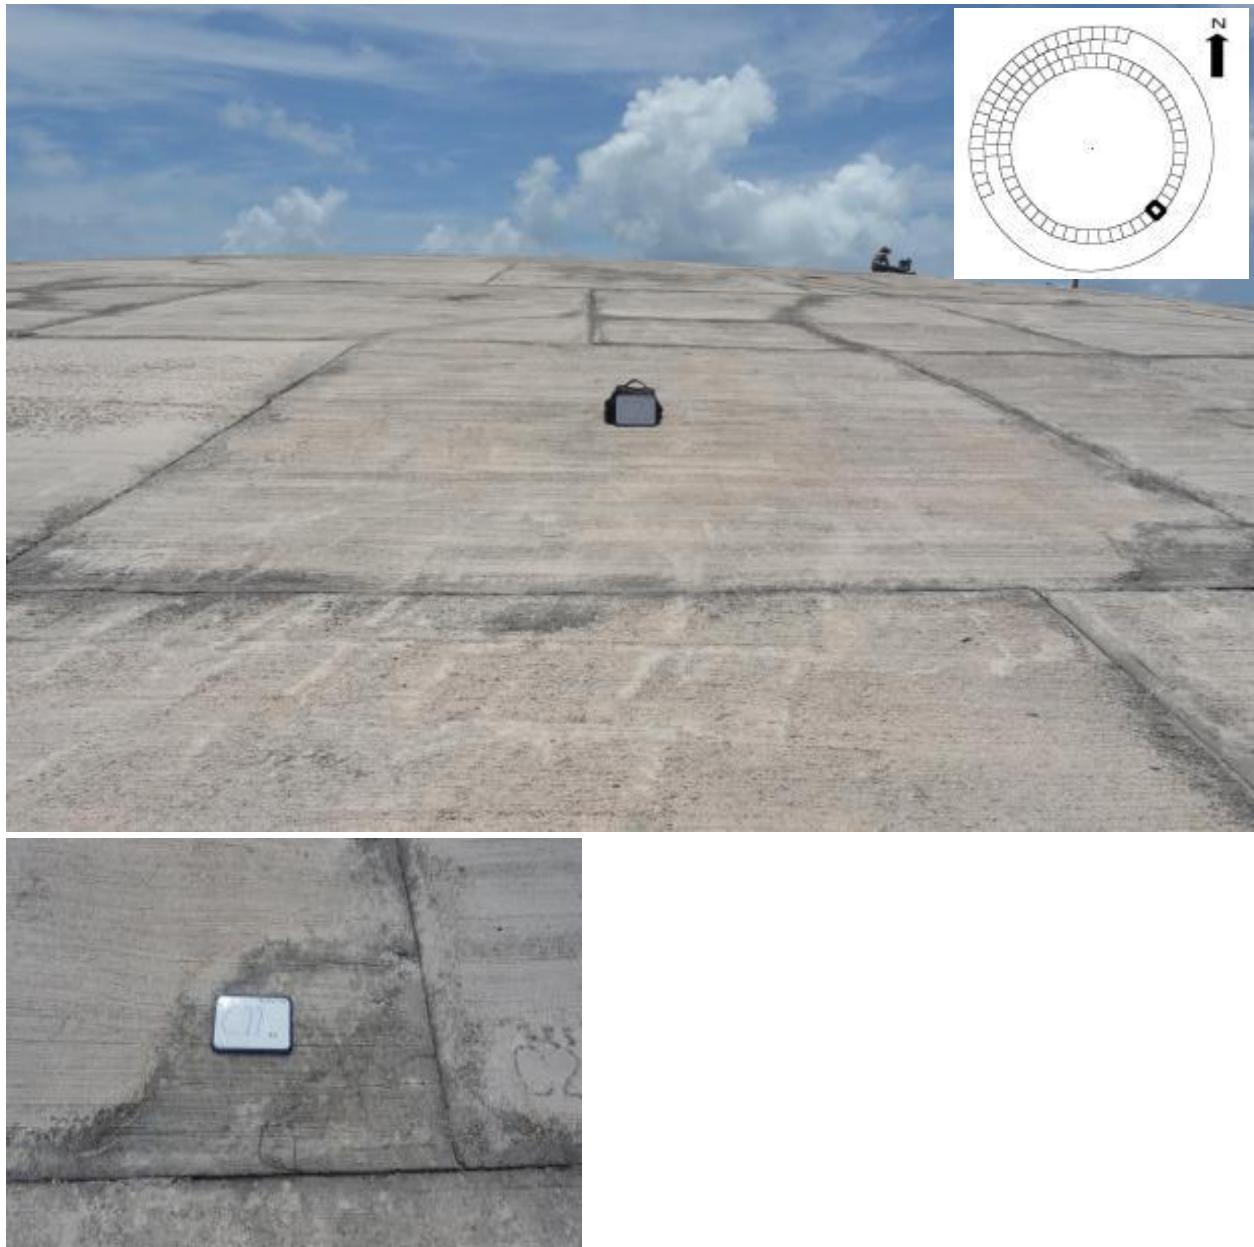
The panel occupies position C24. Cracks along the seam lines appear to be deeper and more obvious. Spalling of concrete in the lower right-hand corner – the affected section of concrete occupies an area approaching 1 m². A small void about 2 centimeters deep and 2 x 1-1.5 centimeters in area was also observed on the upper right-hand side of the panel.

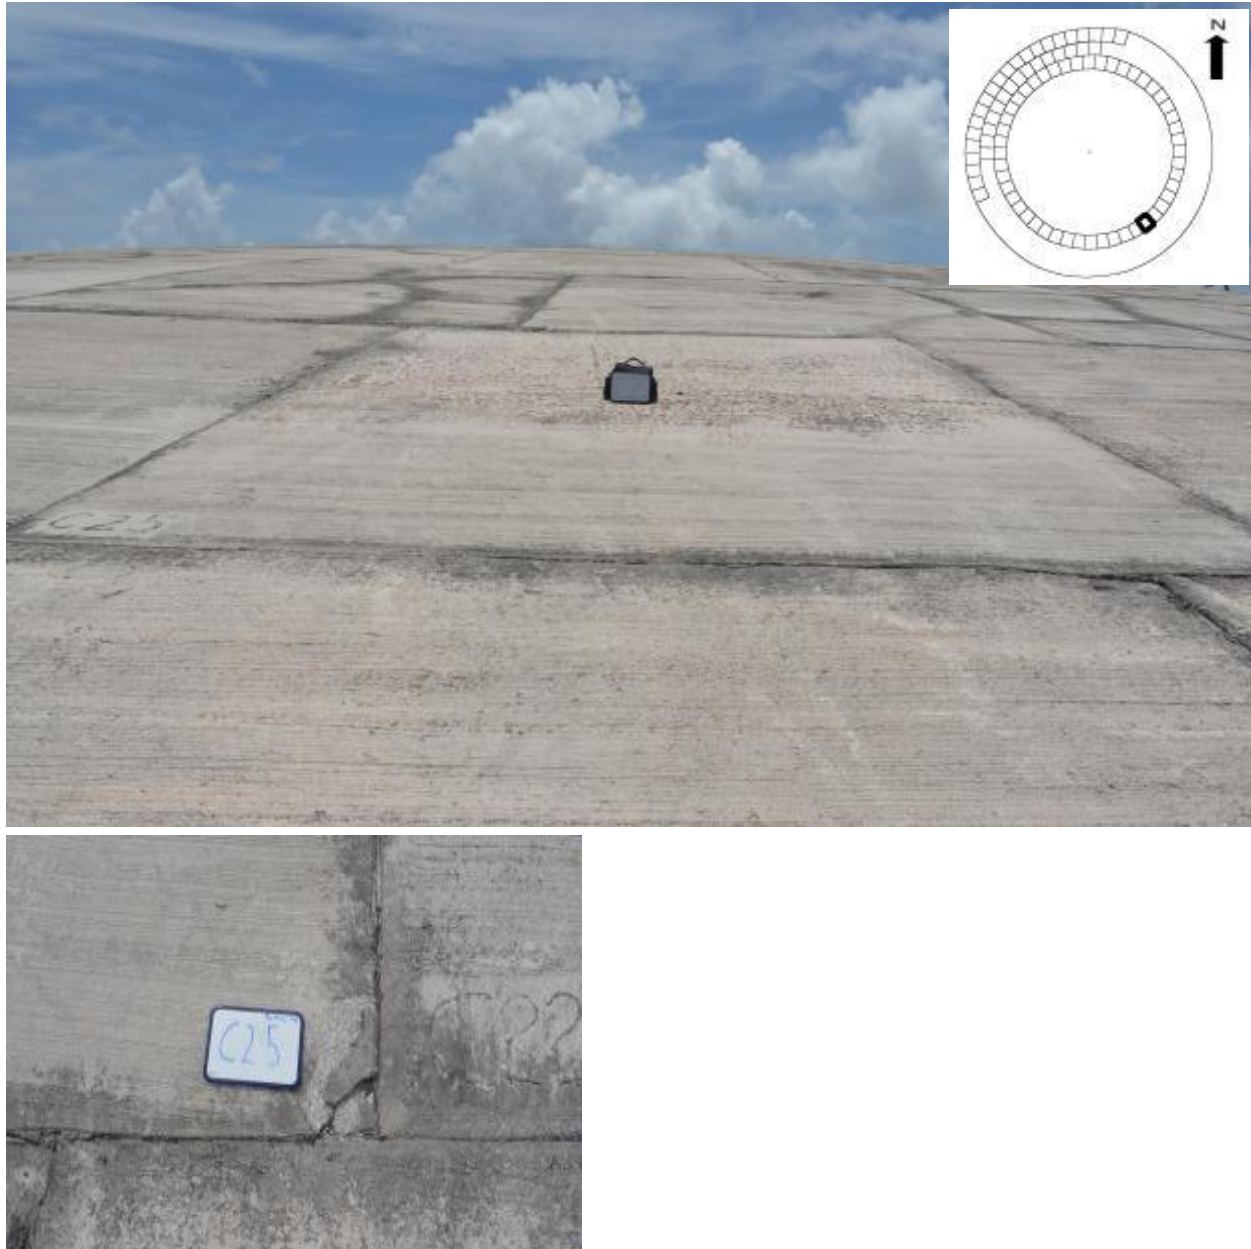
CAP SECTION LOCATION: Panel C25

No significant or obvious interior cracks extending across the top of the panel. The cracks along the panel joints appear to be deeper and more obvious compared with panels in adjacent ring rows. Some spalling/cracking of concrete observed in the lower right-hand corner of the panel.

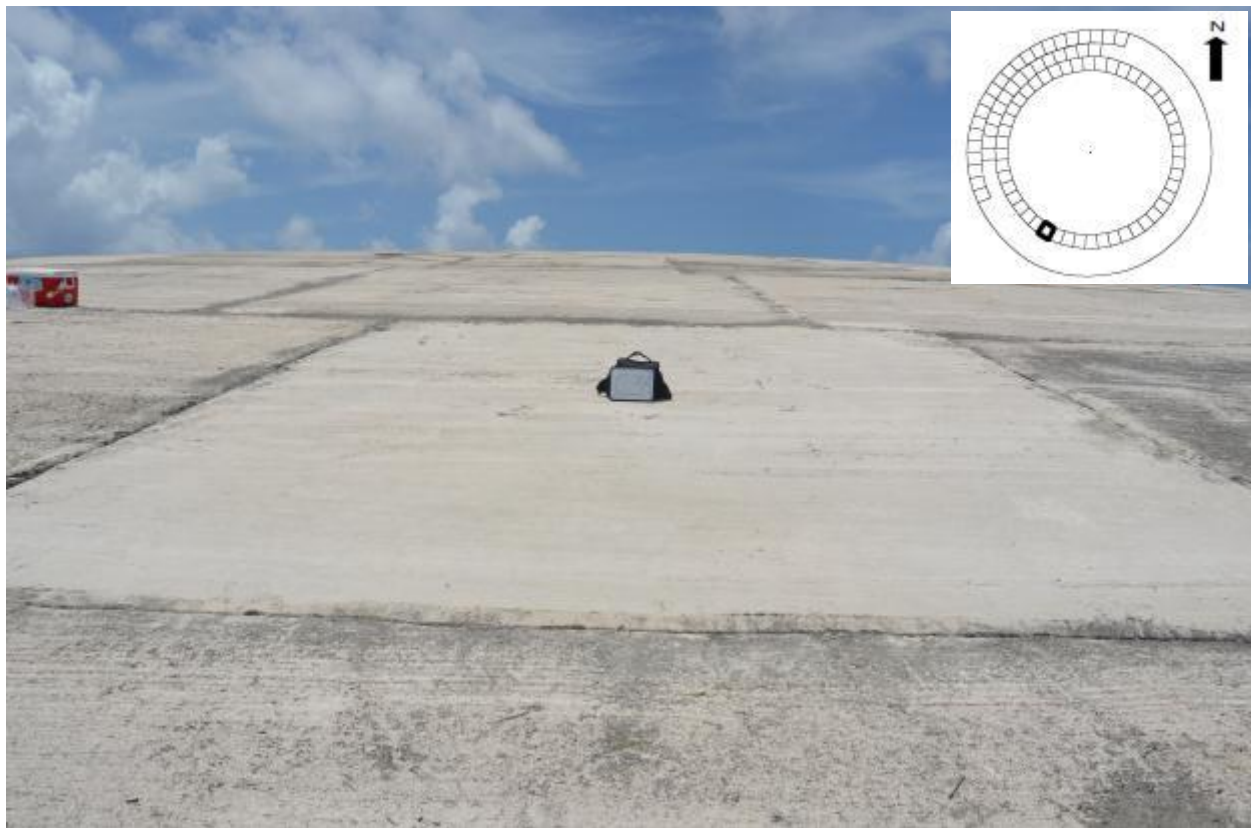
No significant or obvious interior cracks extending across the top of the panel. The cracks along the panel joints appear to be deeper and more obvious compared with those appearing around panels on adjacent ring rows. Some spalling/cracking of concrete observed in the upper right-hand corner of the panel.

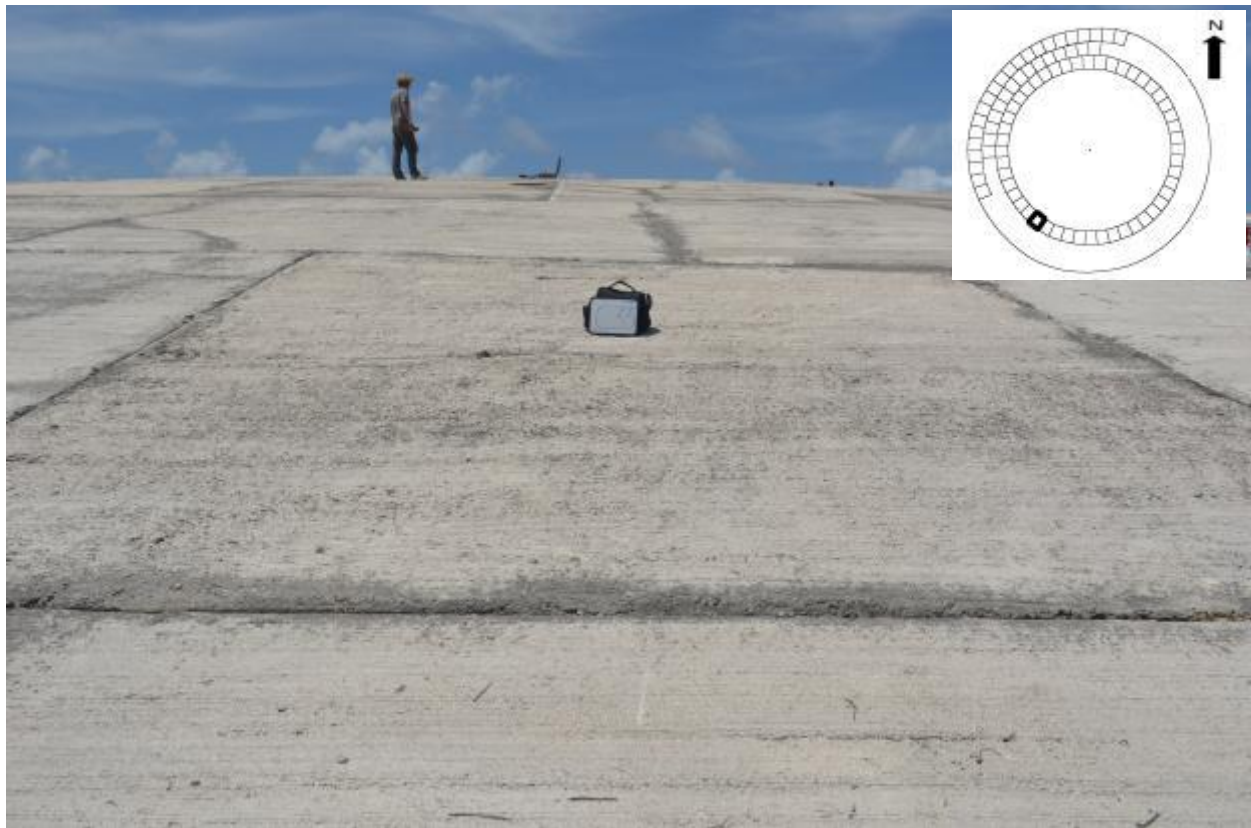
CAP SECTION LOCATION: Panel C35

No significant or obvious interior cracks extending across the top of the panel. Panel has a rough and weathered appearance. The cracks along the panel joints appear to be deeper and more obvious compared with those appearing around panels on adjacent ring rows. Some spalling/cracking of concrete observed in the upper left-hand corner of the panel. Rooting vegetation removed from along the panel seams.
